WESTERN REGIONAL OFFICE DATE: 03.27.08 SHEET NO. 2 OF 5	PROJECT NO. CA-0443-003 DINGVILLE DUCK CLUB WETLAND RESTORATION SITE PLAN - NORTH FIELDS	DESIGNED BY: WAK DRAWN BY: JCS SURVEYED BY: JTS CHECKED BY:
	APPROVED BY:	APPROVED BY:

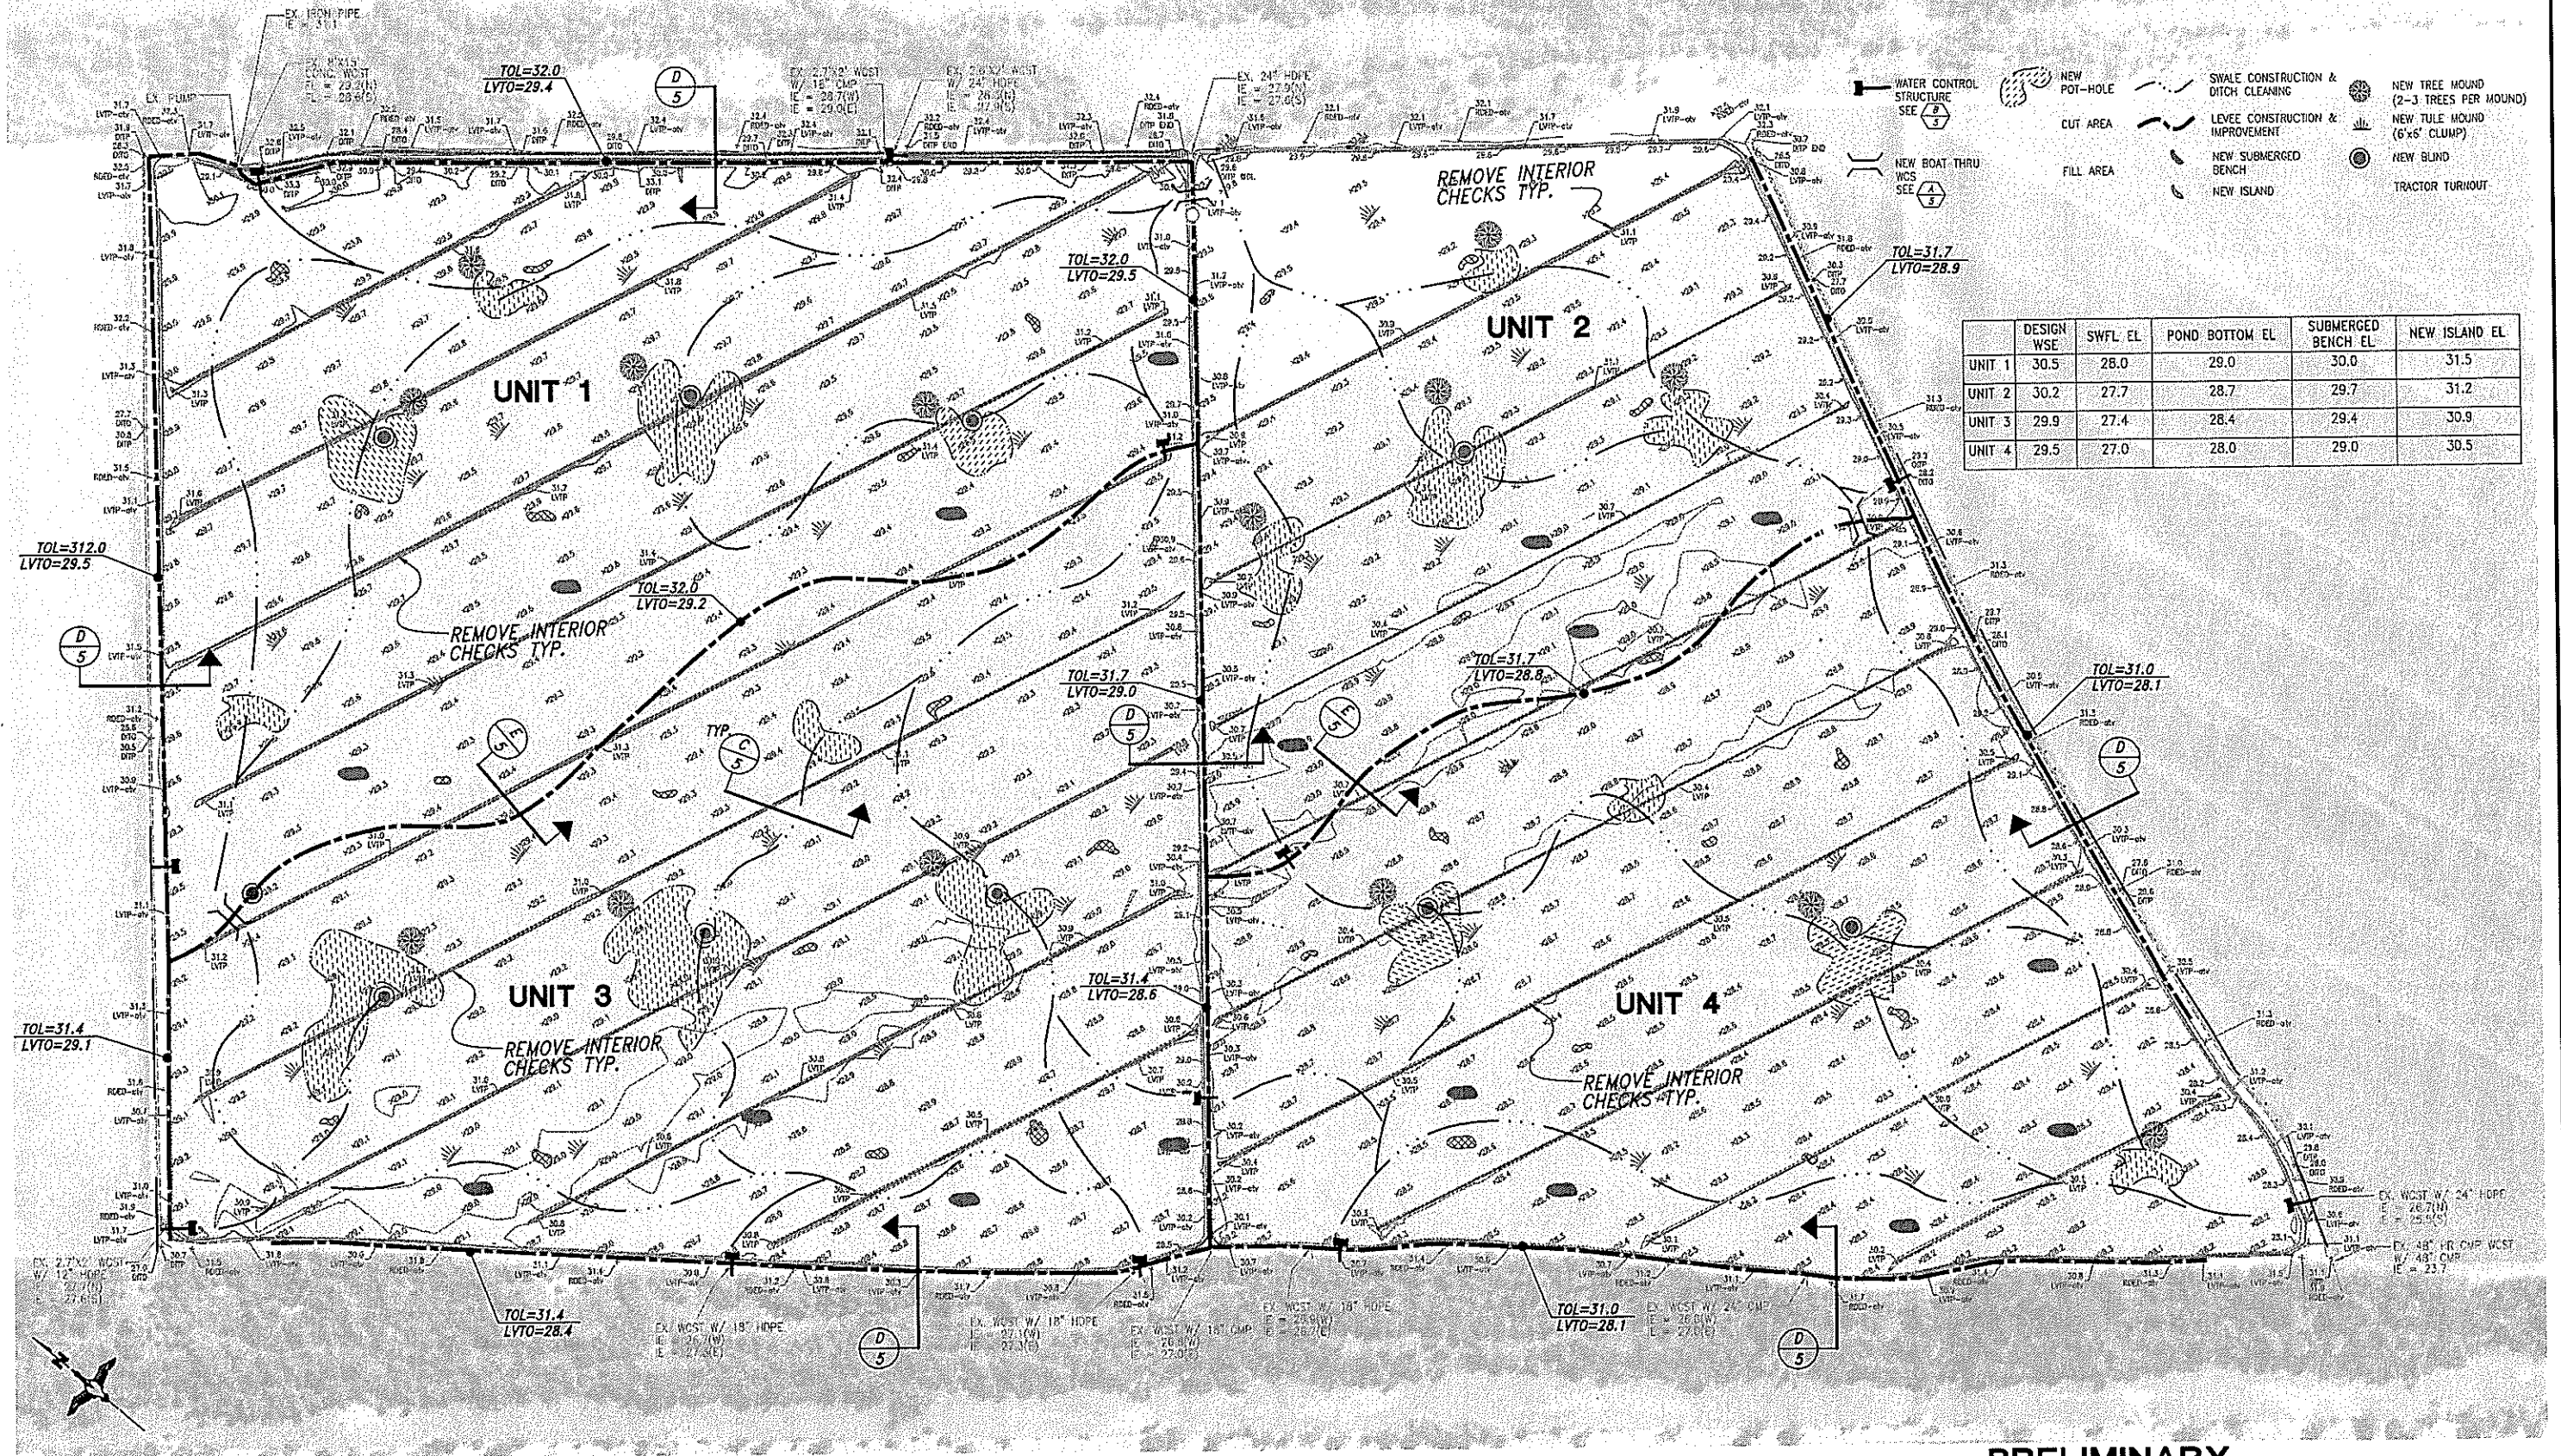
DESIGN WSE	SWFL EL	POND BOTTOM EL	SUBMERGED BENCH EL	NEW ISLAND EL
UNIT 1	30.5	28.0	29.0	30.0	31.5
UNIT 2	30.2	27.7	28.7	29.7	31.2
UNIT 3	29.9	27.4	28.4	29.4	30.9
UNIT 4	29.5	27.0	28.0	29.0	30.5
